Fire Resistance Test In
Accordance With BS EN
1365-2: 2014, On A
Loadbearing Timber Floor
Construction Protected By
A Plasterboard Ceiling And
Incorporating Four Lumi-
Plugin DownLights

416098

**Sleep Safe System Ltd
T/A Lumi-Plugin**

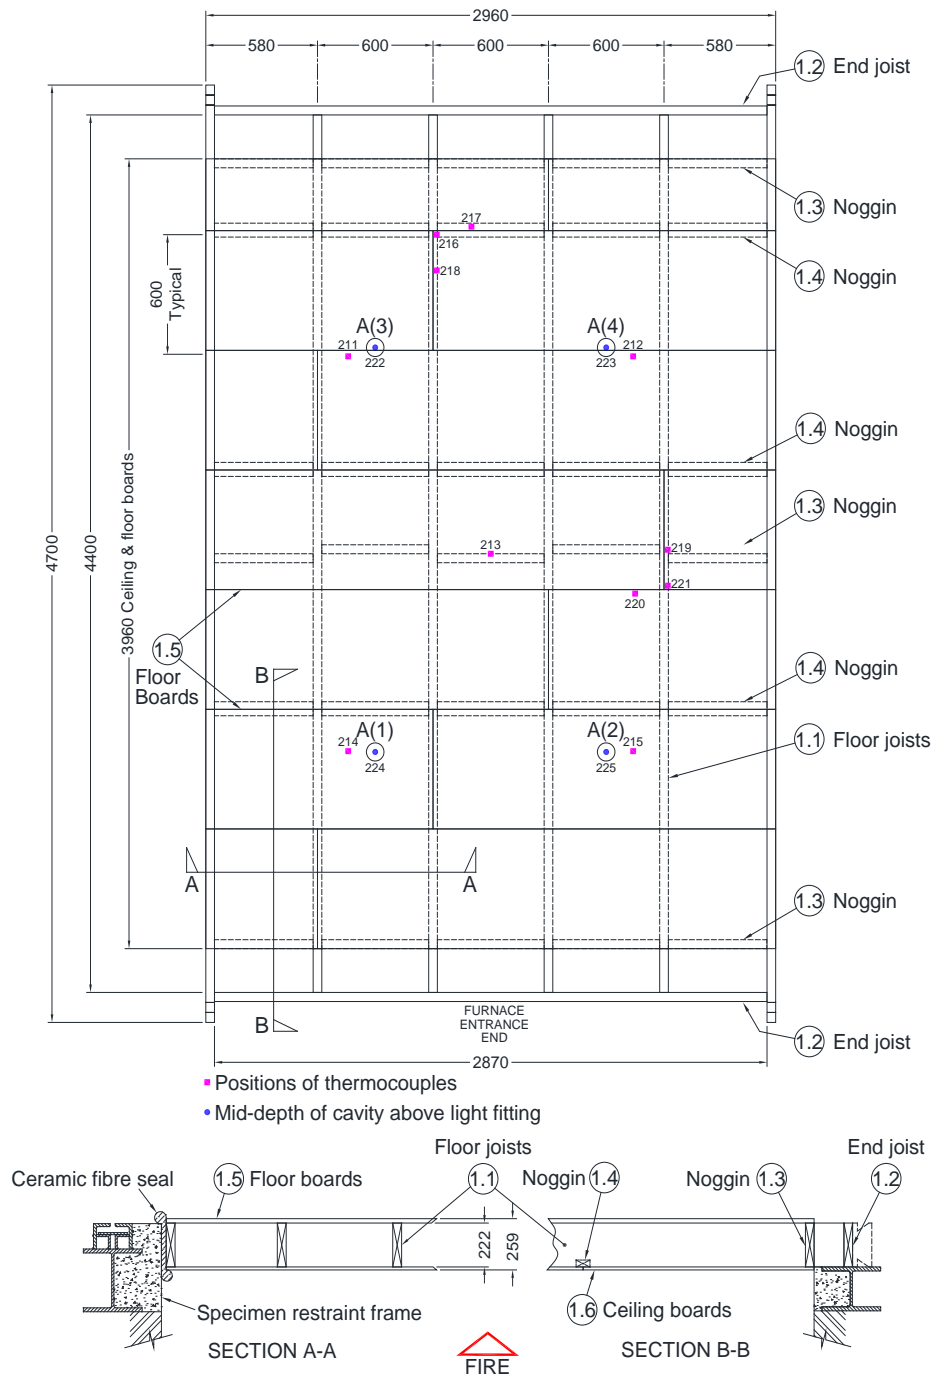
Figure 1- General Elevation of the Unexposed Face of the Test Construction

| Thermocouples | <p>Thermocouples were provided to monitor the unexposed surface of the specimen. The output of all instrumentation was recorded at no less than one minute intervals. The locations and reference numbers of the various mineral insulated (internal thermocouples) and unexposed surface thermocouples are shown in Figure 1</p> |

| <u>Item</u> | <u>Description</u> |
|---|--|
| Fixing | : Fitted at each end of the floor joists and fixed with fired nails. Please see Figure 1 for positions |
| Fixing | : Fitted between floor joists and fixed with fired nails. Please see Figure 1 for positions |

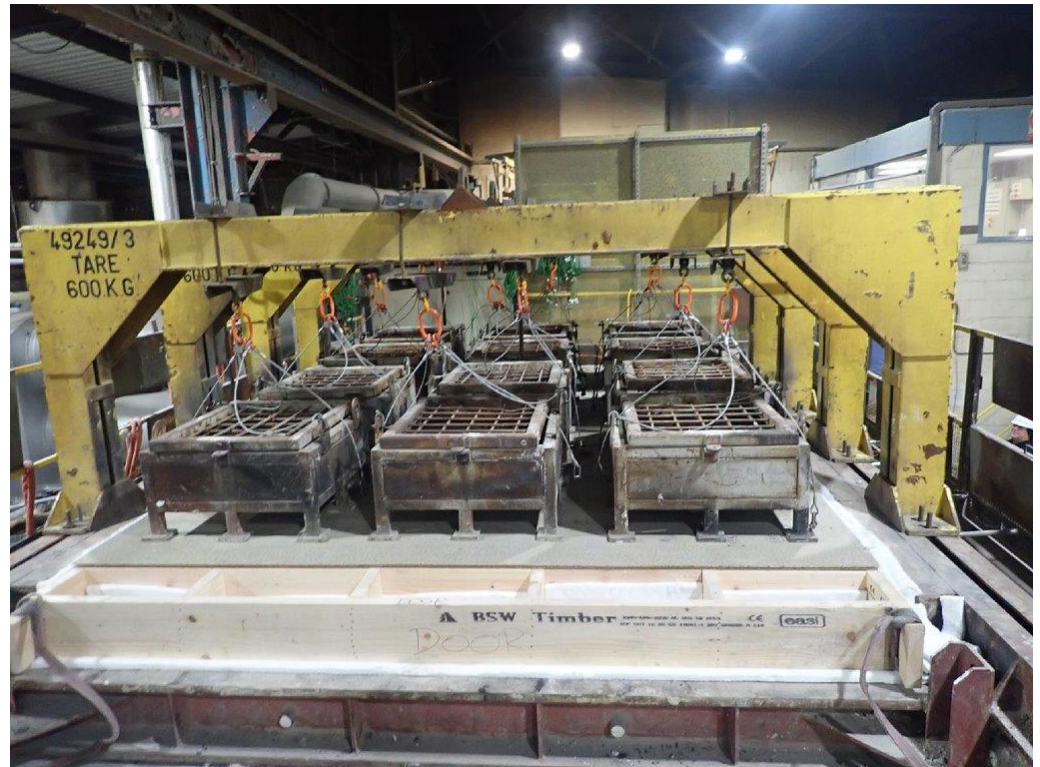
The unexposed face of the floor assembly prior to test

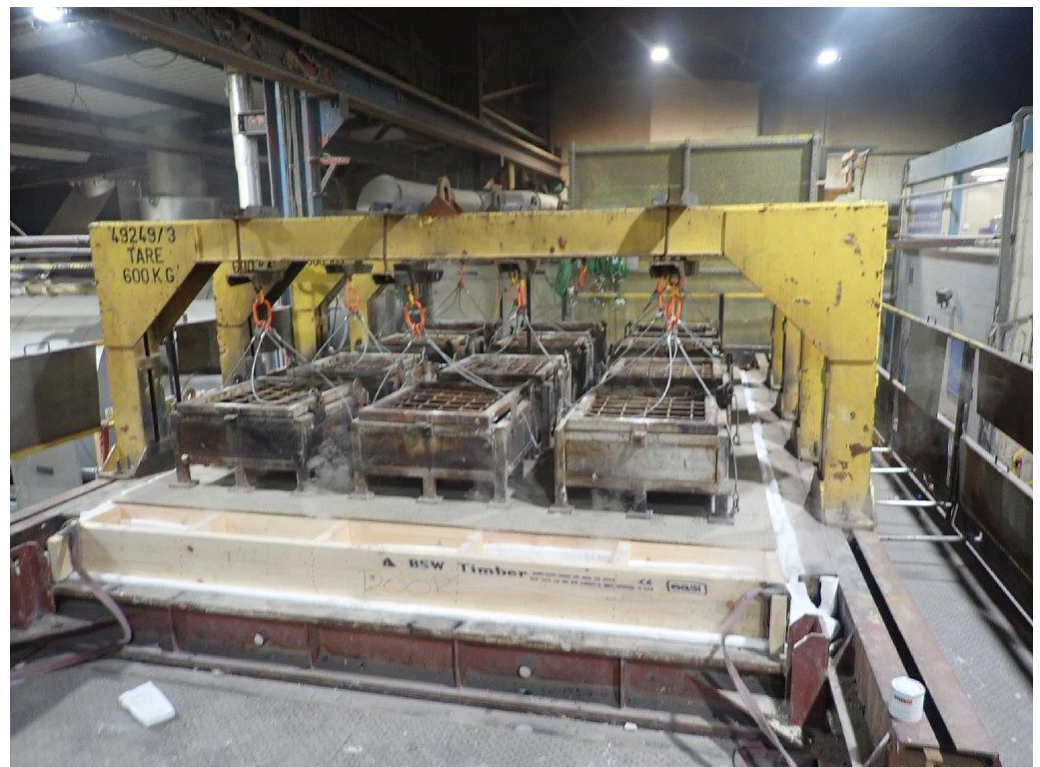
The unexposed face of the floor assembly after 20 minutes of testing

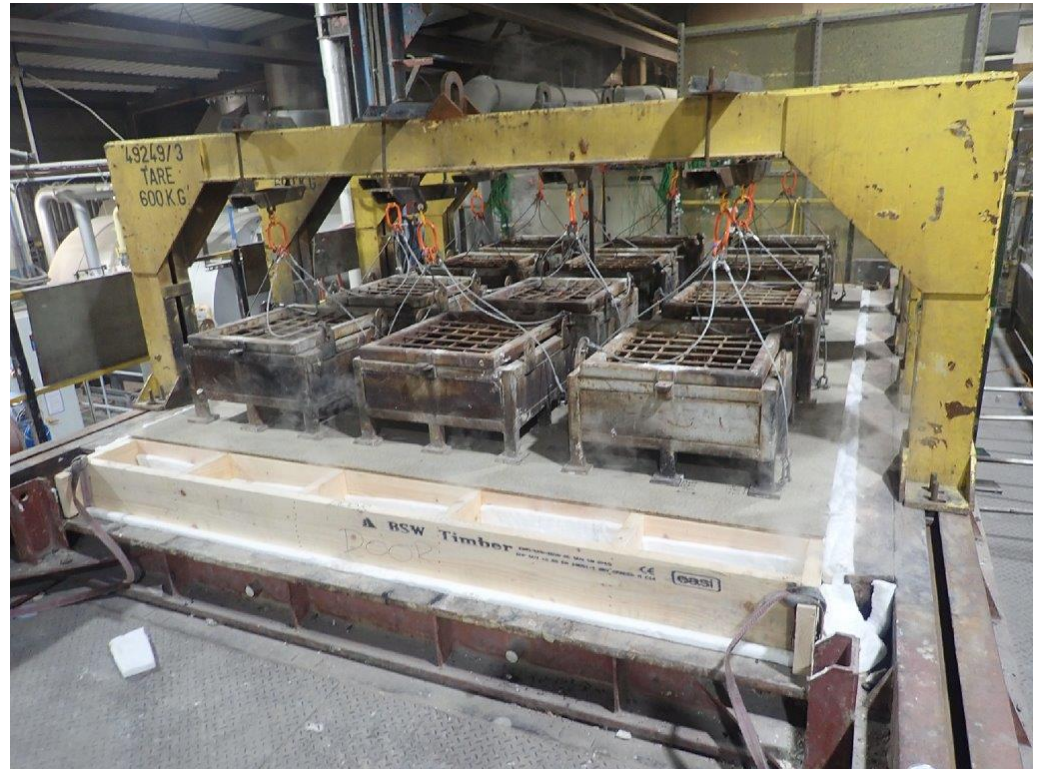
The unexposed face of the floor assembly after 26 minutes of testing

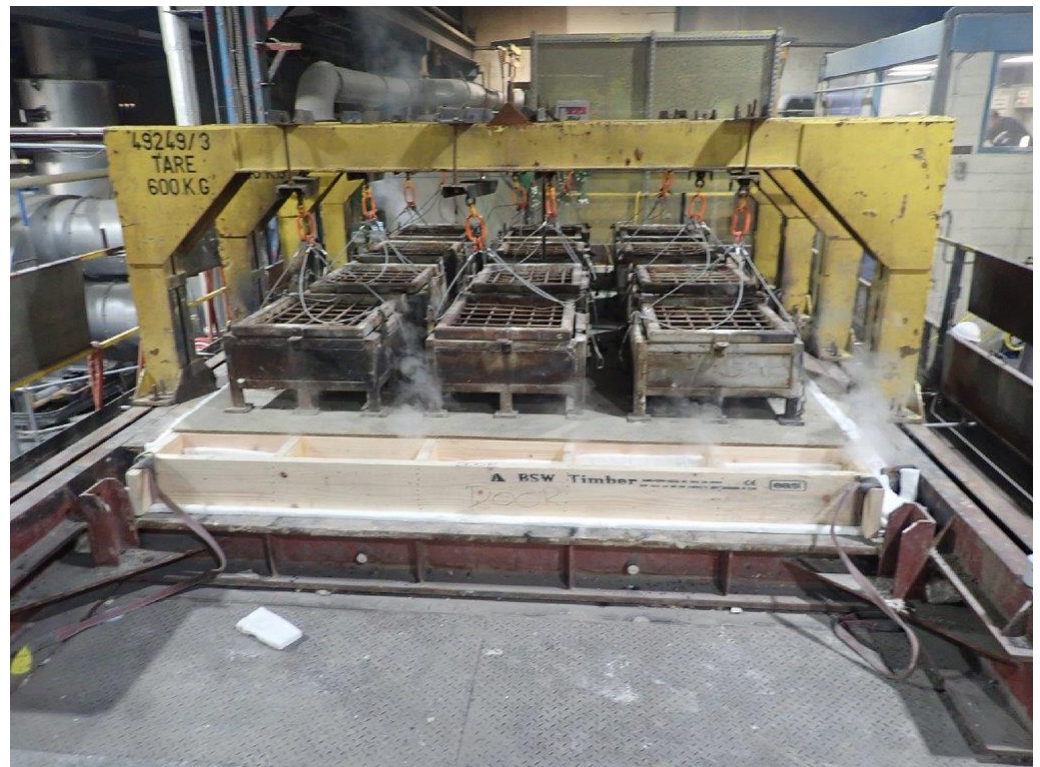
The unexposed face of the floor assembly after 30 minutes of testing

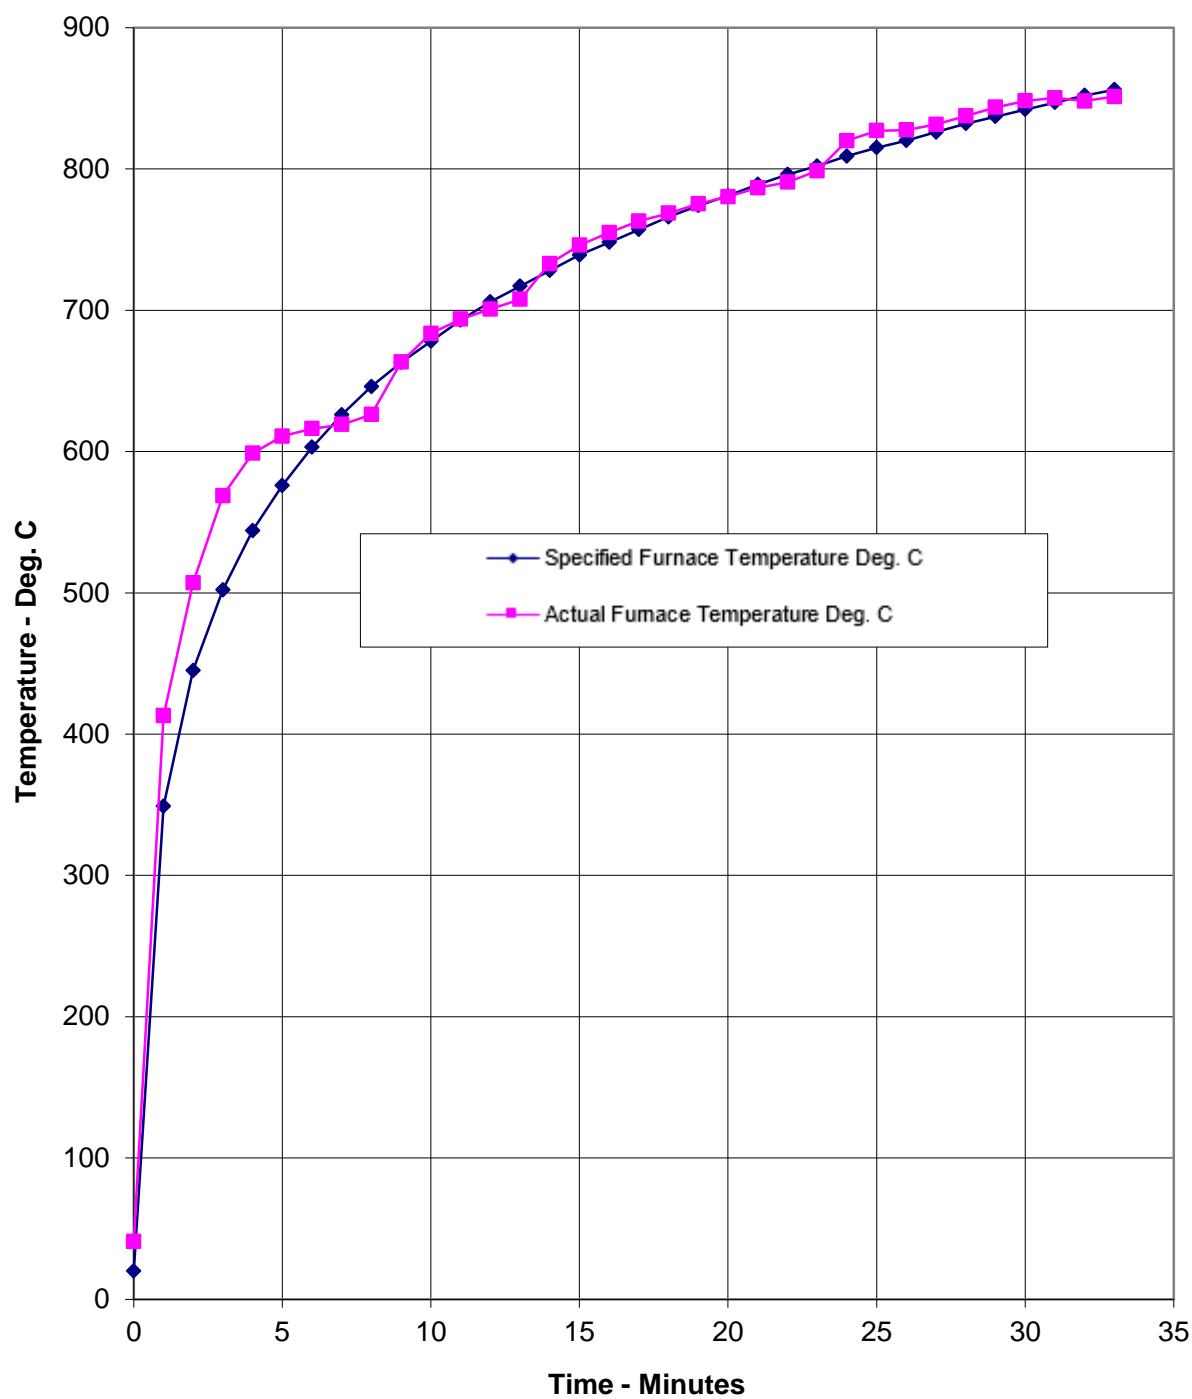
Graph Showing Mean Furnace Temperature, Together With The Temperature/Time Relationship Specified In The Standard BS EN 1363-1: 2012

| Furnace | <p>The furnace was controlled so that its mean temperature complied with the requirements of BS EN 1363-1: 2012 Clause 5.1 using eight plate thermometers, distributed over a plane 100 mm from the underside of test assembly.</p> |

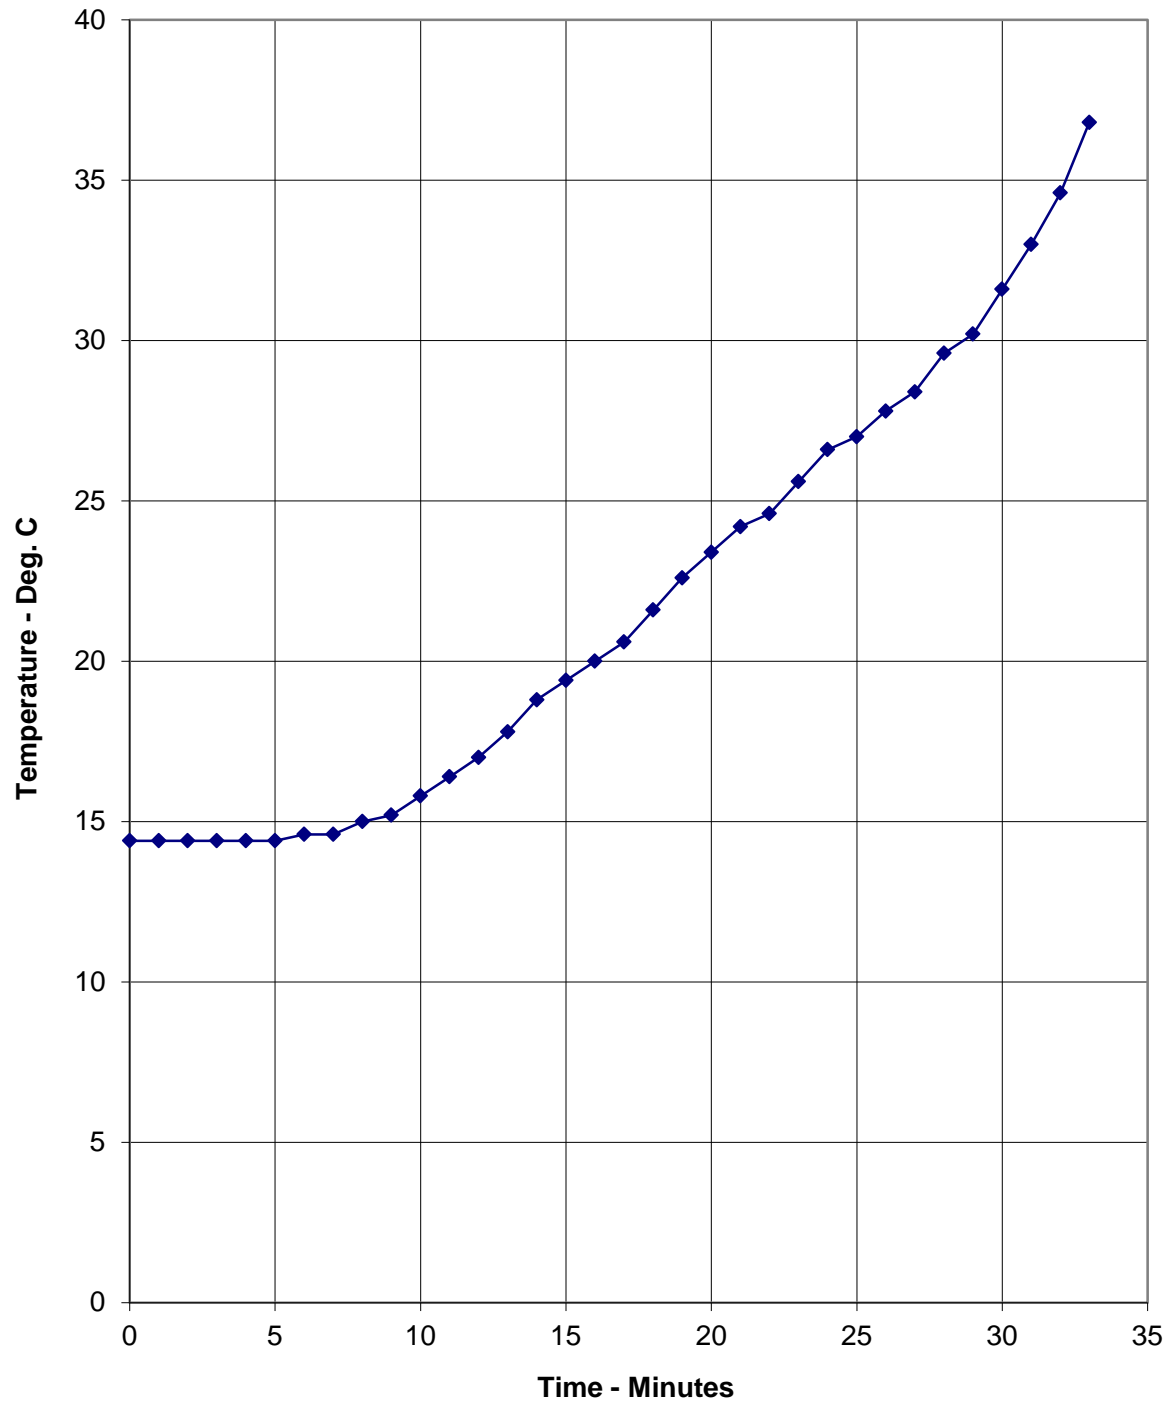
Graph Showing Mean Temperature Recorded On The Unexposed Surface Of The Specimen

It is required that the mean temperature rise of the unexposed surface shall not be greater than 140°C and that the maximum temperature rise shall not be greater than 180°C. Insulation failure also occurs simultaneously with integrity failure.
These requirements were satisfied for the period shown below:

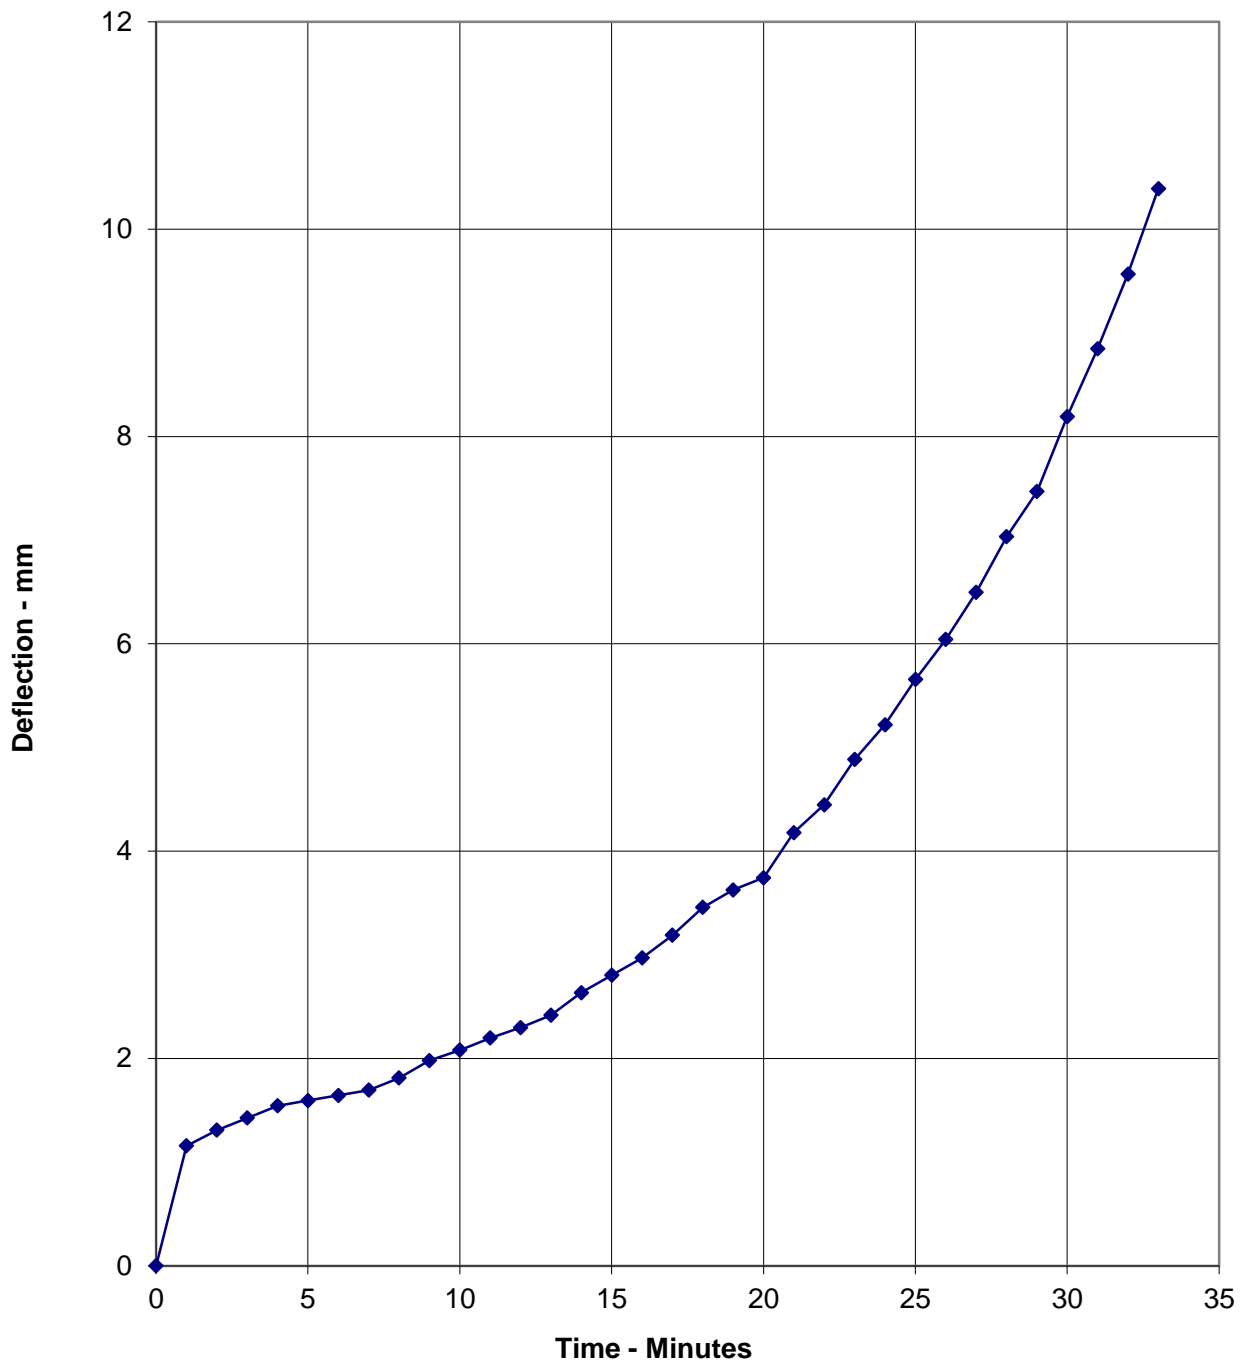
Graph Showing The Recorded Vertical Deflection and Rate Of Deflection Of The Specimen

| Loadbearing Capacity Criteria | <p>A linear deflection transducer was provided at the approximate centre on the unexposed surface of the specimen to record its vertical deflection.</p> |

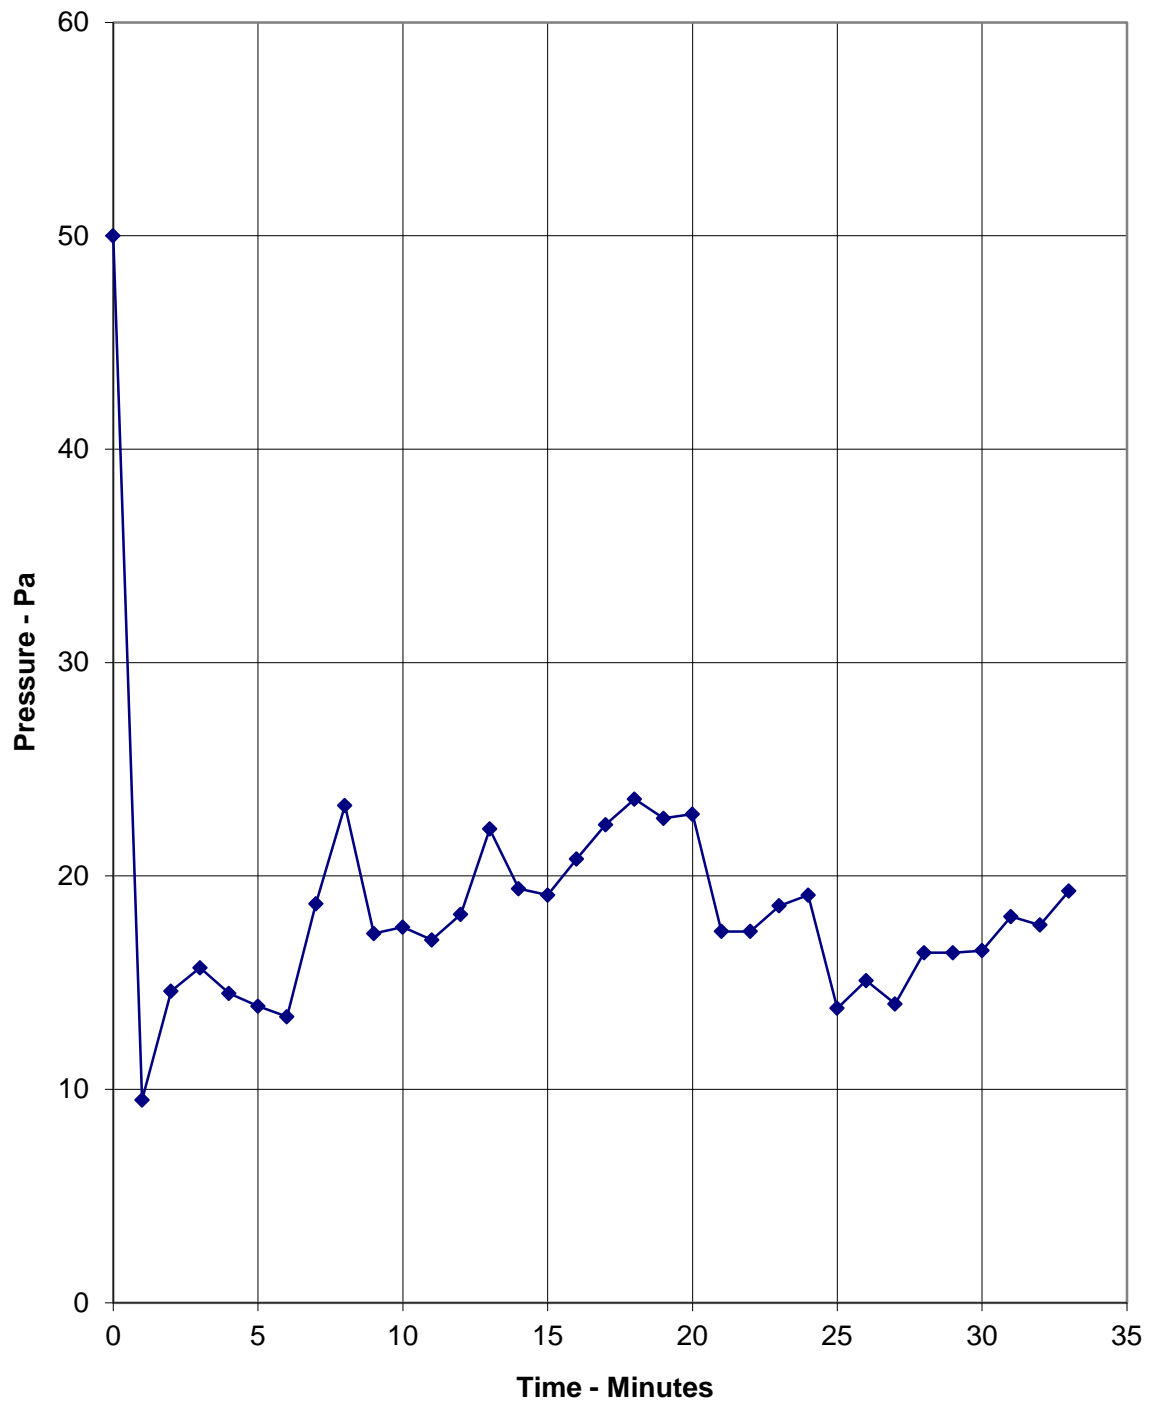
Graph Showing Recorded Furnace Pressure 100 mm Below The Underside Of The Specimen

| Furnace Pressure | <p>After the first five minutes of testing and for the remainder of the test, the furnace atmospheric pressure was controlled so that it complied with the requirements of BS EN 1363-1: 2012, clause 5.2.1 The calculated pressure differential relative to the laboratory atmosphere 100 mm below the soffit of the specimen was 18 (± 5) Pa between 5 and 10 minutes and 18 (± 3) Pa thereafter.</p> |

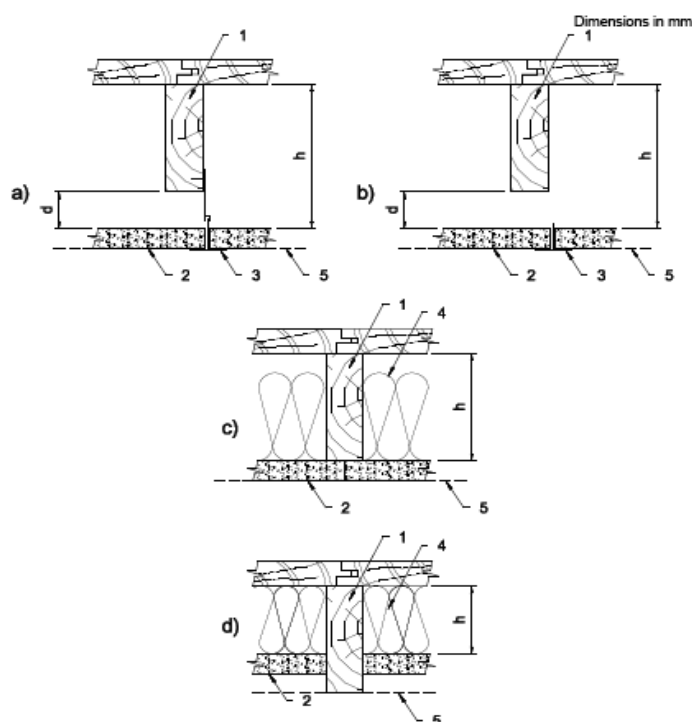
The height of the cavity 'h' and the minimum distance 'd' between the ceiling and the structural members (see Figure below) are equal to or greater than those tested.

| a) suspended ceiling | 4 insulation |
| b) self-supported ceiling | 5 pressure reference line |
| c) and d) direct fixed ceiling with insulation in cavity | d distance between ceiling and structural members |
| 1 supporting construction (joist) | h height of cavity |
| 2 ceiling lining | |
| 3 supporting frame | |
